**FRETTING FATIGUE CRACKING OF A 936 MW TURBO-  
GENERATOR ROTOR  
FAILURE ANALYSIS AND REFURBISHMENT**

**1 ABB Power Generation Ltd Switzerland**

**2 SENSOPLAN GmbH**

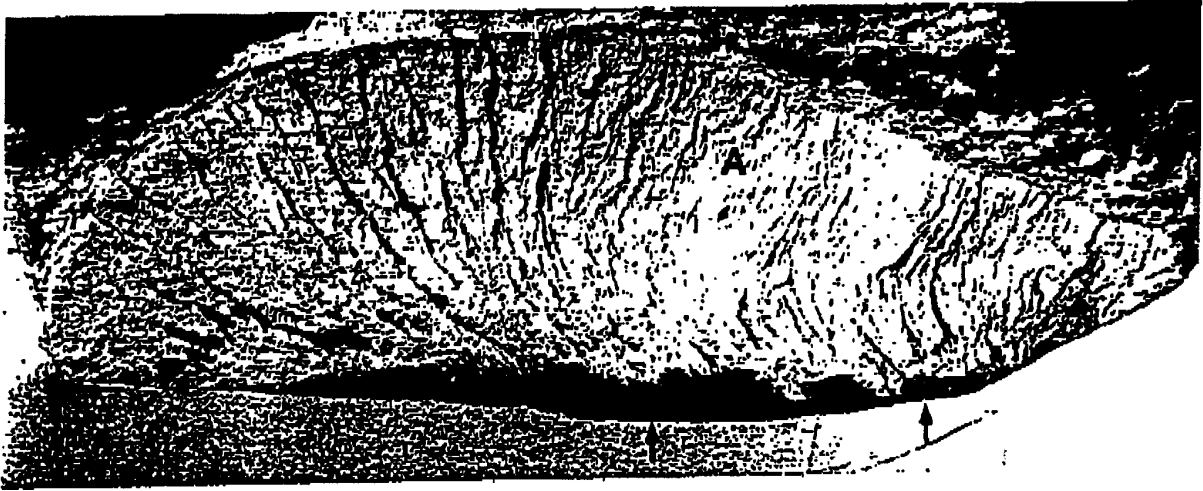
**Fig. 4**

In order to investigate the cracks which had formed in the wedge lands of the winding connection slots after 4000 hours of operation (Fig.3), cylindrical specimens were cut from the wedge slots and broken open in the laboratory. Again the typical characteristics of fretting loading were visible on the surfaces of the wedge and wedge slot. Material from the aluminium alloy of the wedges could be detected on the fracture surfaces of the wedge slot specimens down to a depth of ca. 1 mm (Fig.4). This is also a clear indication of the fretting loading. A further indication was given by the determination of the ratio of crack depth to surface crack length, which was less than 0.25 for most of the cracks. This value is characteristic for cracks for which initiation and propagation are primarily driven by shear stresses. If, on the other hand, the tensile stress is dominant then almost semicircular cracks are formed with a ratio of approximately 0.5.

**Fig.4: Broken-open fretting fatigue crack in wedge land of slot 3.**

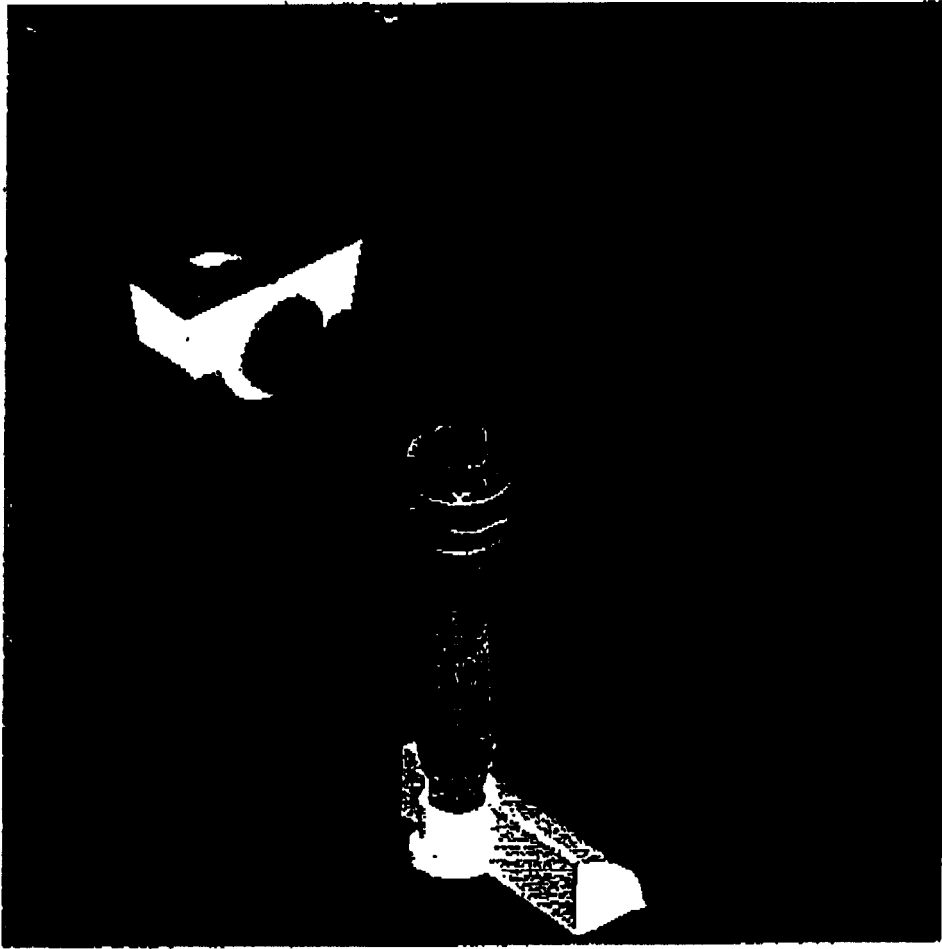
Fig. 5b

The design principle of the contact free winding connection is described in the following. The thread for the retaining nut was drilled out and the copper current lead bolt was exchanged for a free-standing steel bolt (Figs.5a,5b). Since the mechanical properties of the steel bolt are much better than those of the previously used copper alloy, it was possible to omit the retaining nut. The steel bolt was fixed in the lead in bar through a steel sleeve with a conical form. However, as a result of the much higher electrical resistance of steel, it was necessary to increase the cooling effect through increasing the gas flow rate. This was achieved by using the full fan pressures in order to improve cooling of the steel bolts. This concept is standard for today's H<sub>2</sub>-cooled ABB generators.

**Fig.5b: "3D solid model" of contact free winding connection.**
